# Interferometric Synthetic Aperture Radar (InSAR) and field-based observations of rainfall-triggered landslides from the November 2021 storm, Gisborne/Tairāwhiti, New Zealand

Matt Cook<sup>1</sup> | Martin Brook<sup>1</sup>

<sup>1</sup>School of Environment, University of Auckland, Auckland, New Zealand

<sup>2</sup>Gisborne District Council, Gisborne, New Zealand

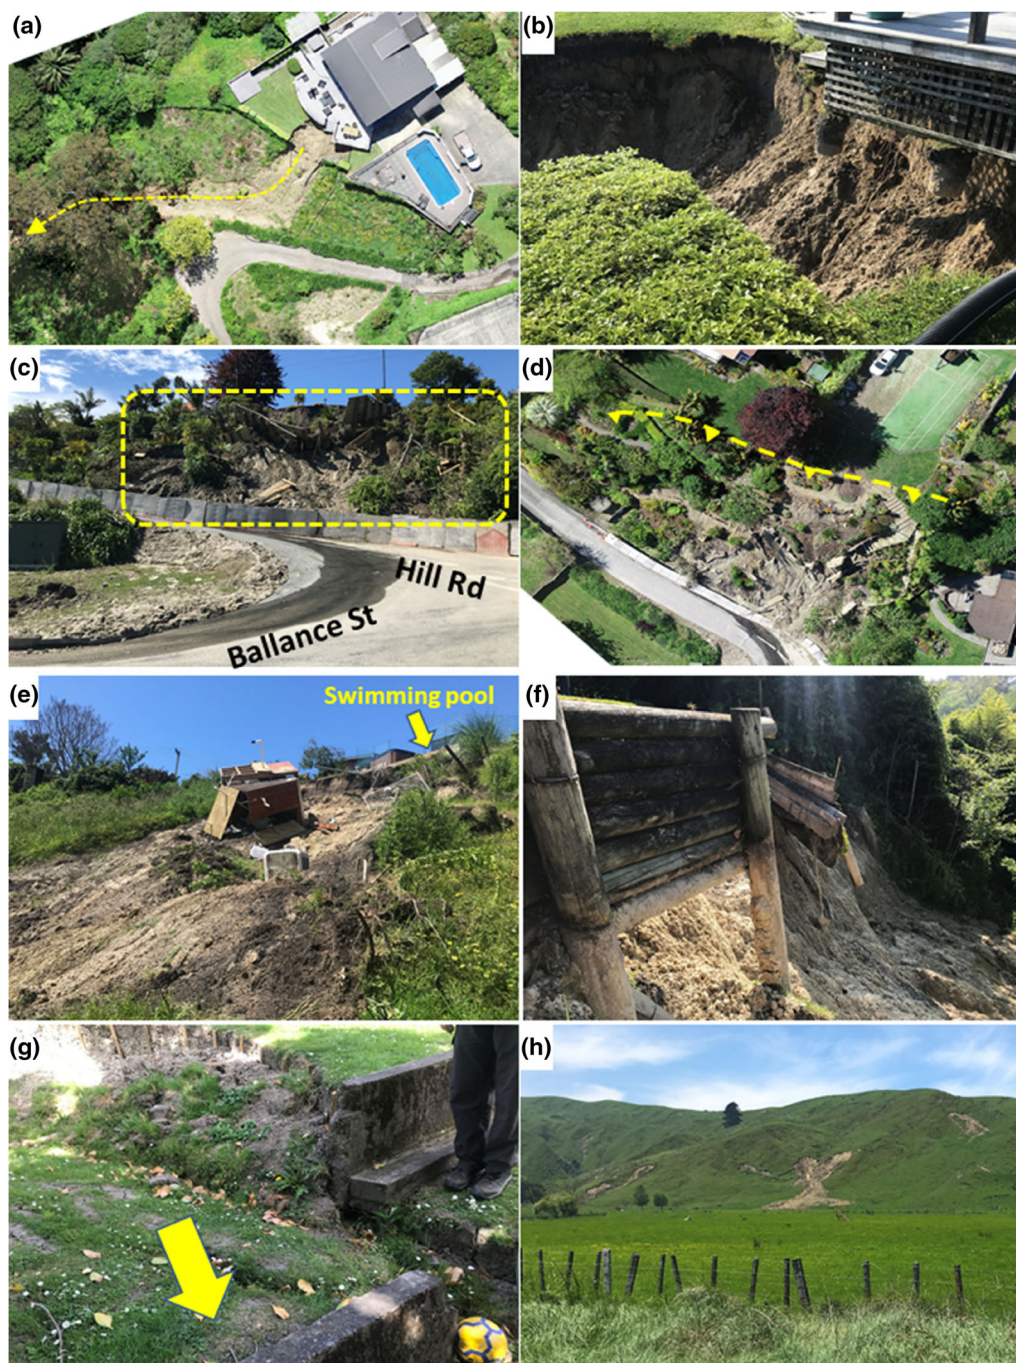
**FIGURE 3** (a and b) Slump-flow at Clifford Street undermining deck, tilting swimming pool; (c and d) Ballance Street fill/retaining wall failure, where cantilever embedded pole retaining wall has rotated; (e) Gaddum's Hill Road earthflow downslope towards 17 Darwin Road; (f) retaining wall failure at Owen Road above Waimata River; (g) scarpnet and offset retaining wall from low angle slump at Argyll Street; (h) shallow earthflows at Wheatstone Road.

city and suburbs visited the week following the November 2021 storm, that had particular impacts on residential property. The numbers in the first column of Table 1 correspond with the numbers on Figure 1b. The landslides exhibited typical characteristics of previous rainfall-triggered landslides in the Gisborne region. They are mainly shallow (<2 m) slumps on slopes with initiation angles ( $A_s$ ) of 25–35°, that transition downslope into earthflows, with runout usually topographically-constrained within existing gullies. Material types that failed include fill (e.g., Hill Road, L8), fluvial deposits (e.g., Owen Street, L12), residual soils, and colluvium (e.g., Gaddums Hill Road, L16). Occasionally, the slope failures incorporated some highly-weathered rock (Richardson Avenue, L10). Some images of example November 2021 landslides are shown in Figure 3. In particular, Clifford Street landslide (L6) commenced as a rotational slump under the deck, then accelerated downslope as a flow, which inundated the rear of a property below (Figure 3a,b). Tilting of the swimming pool also occurred, and the additional effect of slope loading from the swimming pool may have contributed to slope instability.

A remarkable landslide occurred at the intersection of Hill Road and Ballance Street (Figure 3c,d). This was a fill failure, where the natural land surface had been extended southwest to accommodate a tennis court and floodlights, as ‘made ground’. This was composed of locally-sourced soil as the fill, which was retained via a retaining wall consisting of embedded timber poles, with timber planks as the ‘lagging’. The earthflow extended ~40 m down Ballance Street, across the road and grass verge. At the Darwin Road slump-earthflow, a swimming pool was also present immediately adjacent to the headscarp (Figure 3e). This landslide exhibited high mobility,

extending >120 m downslope into a property on Darwin Road, below. Embedded timber poles in the retaining wall were exposed at Owen Road, where the riverbank below the property was under-cut, and slumped, and the retaining wall failed (Figure 3f).

In contrast to the typically more mobile earth flows, at Argyll Street a low angle slump initiated on a slope of ~12°, with the headscarp in a back garden, and displacement away from the house, downslope to the west (Figure 3g). Slope velocity was unwittingly accelerated somewhat by the downslope (adjacent) landowner excavating the toe of the slump. On the edges of suburban Gisborne, shallow earthflows occurred on pastureland, and typical examples are shown in grazing paddocks at Wheatstone Road (Figure 3g). These types of landslides are of growing importance in the Wheatstone Road area, due to the residential subdivisions that are being developed (e.g., landslide L21, Table 1).

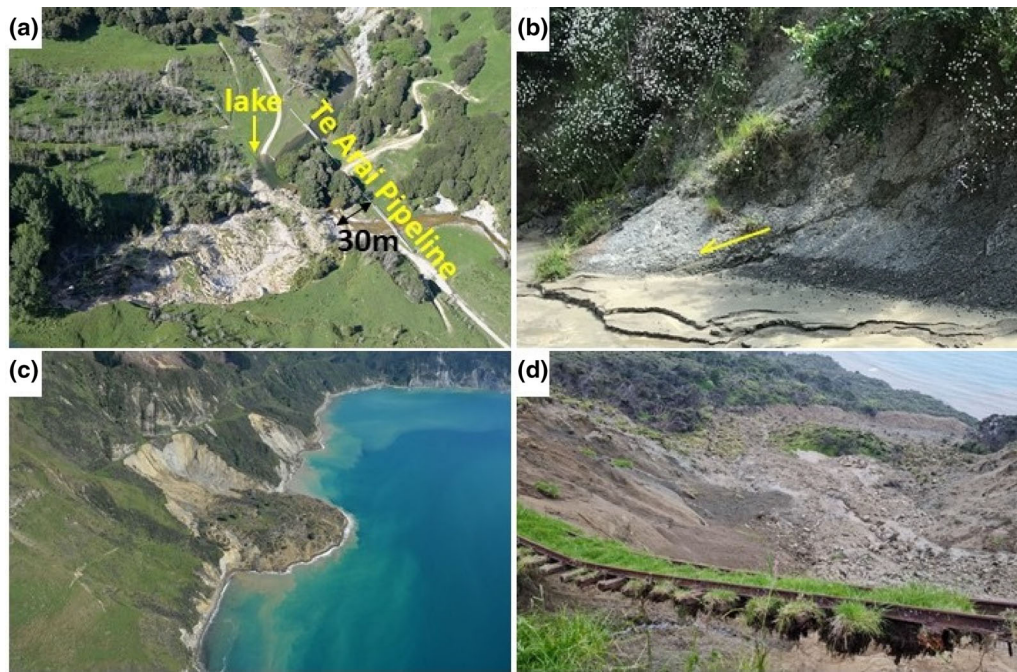
In contrast to the above earthflows, examples of large volume landslide ‘complexes’ are shown in Figure 4. The ~0.17 km<sup>2</sup> Te Arai landslide, 24 km southwest of Gisborne is a large earthflow ‘complex’, and is ~700 m long and has an overall gradient of 18°. Failure is possibly facilitated by bedding planes in the underlying Tolaga Group mudstones (Figure 4b). In November 2021, the landslide terminated 30 m from the Te Arai water pipeline, which transfers the majority Gisborne’s city water supply from Mangapoike Dams to the Waingake Water Treatment Plant. Unfortunately, subsequently during Cyclone Gabrielle in February 2023, the Te Arai pipeline was severely damaged by multiple landslide reactivation and associated mobilisation of large woody debris from adjacent forests, cutting off the majority of Gisborne’s water supply (Sharma, 2023). The November 2021 storm also triggered large volume coastal landslides

**FIGURE 4** Large volume, rural landslide examples: (a) Te Arai landslide complex that reactivated and extended to ~30 from the Te Arai water pipeline, damming the Waingake/Te Arai River, forming a lake; (b) unfavourable mudstone bedding dip exposed near toe; (c) Whareongaonga Landslide including (d) view from headscarp and undercut Wairoa-Gisborne railway line.

in the Tolaga Group sediments, and the Whareongaonga Landslide is one example (Figure 4c,d), ~30 km south of Gisborne. The landslide destroyed culturally important pā and fishing ground for Ngāi Tāmanuhiri. Rosser and Wolter (2022) reported 1.3 million m<sup>3</sup> of soil and rock was displaced by the November 2021 event, with runout below the intertidal zone. The landslide also undercut the Wairoa Gisborne railway line (Figure 4d).

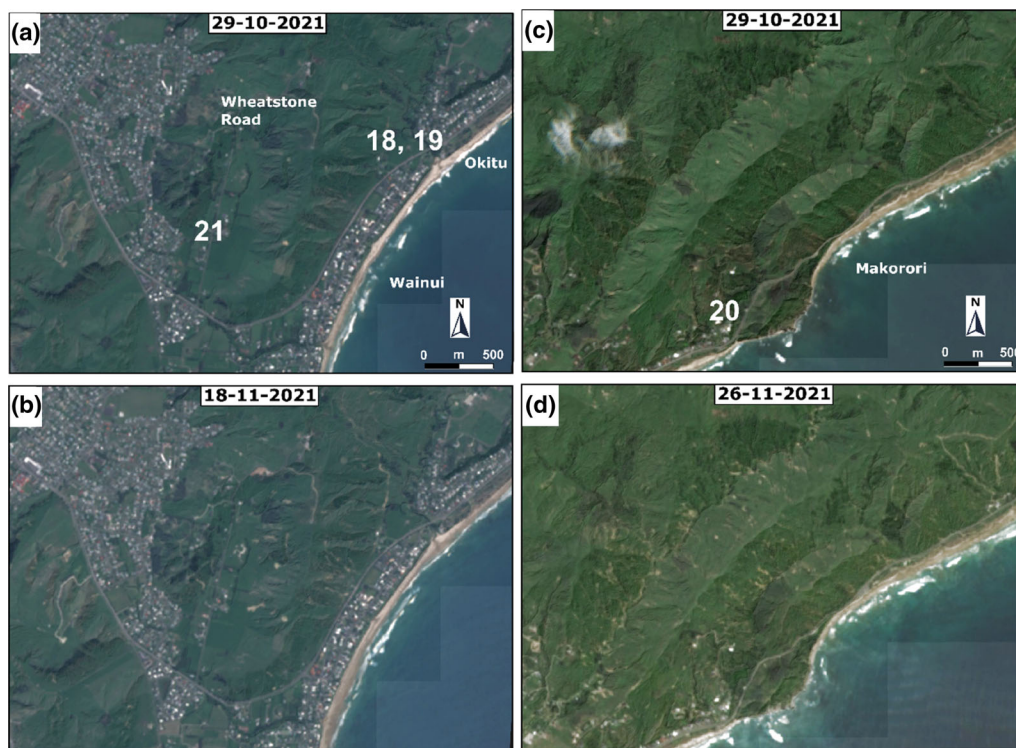
In addition to the information gleaned from the field reconnaissance, Sentinel-2 optical satellite imagery was useful for regional-scale overviews of landsliding in the Wheatstone Road area east of Gisborne (Figure 5a,b), and around the coastal township of Makarori (Figure 5c,d). Indeed, comparing the pre-storm (October 2021) and post-storm Sentinel-2 imagery, linear pale hues are visible on the hill pasture perpendicular to the axes of ridgelines in the post-storm imagery, representing shallow earthflows. Sentinel-1 InSAR results showing annual average slope velocity (2016–2021) is also shown in Figure 6. As can be seen from the Figure 6 plots, most of the points analysed indicate that slopes are deforming at ~15–30 mm/year. A more detailed example of InSAR velocity of slopes around Wheatstone Road (landslide #21) is shown in Figure 7. This landslide is a shallow rotational slump, which transitions downslope into an earthflow (Figure 7a), but is also extending upslope by headscarp retrogression, towards a house. Parts of this landslide exhibit velocities of ~30 mm/year. Figure 7b shows the timeseries of slope velocity of landslide #21 from 2016 to 2021, with the

FIGURE 5 Sentinel-2 optical satellite imagery before and after the November 2021 storm event for the Wheatstone Road area (a and b) and Makorori (c and d).

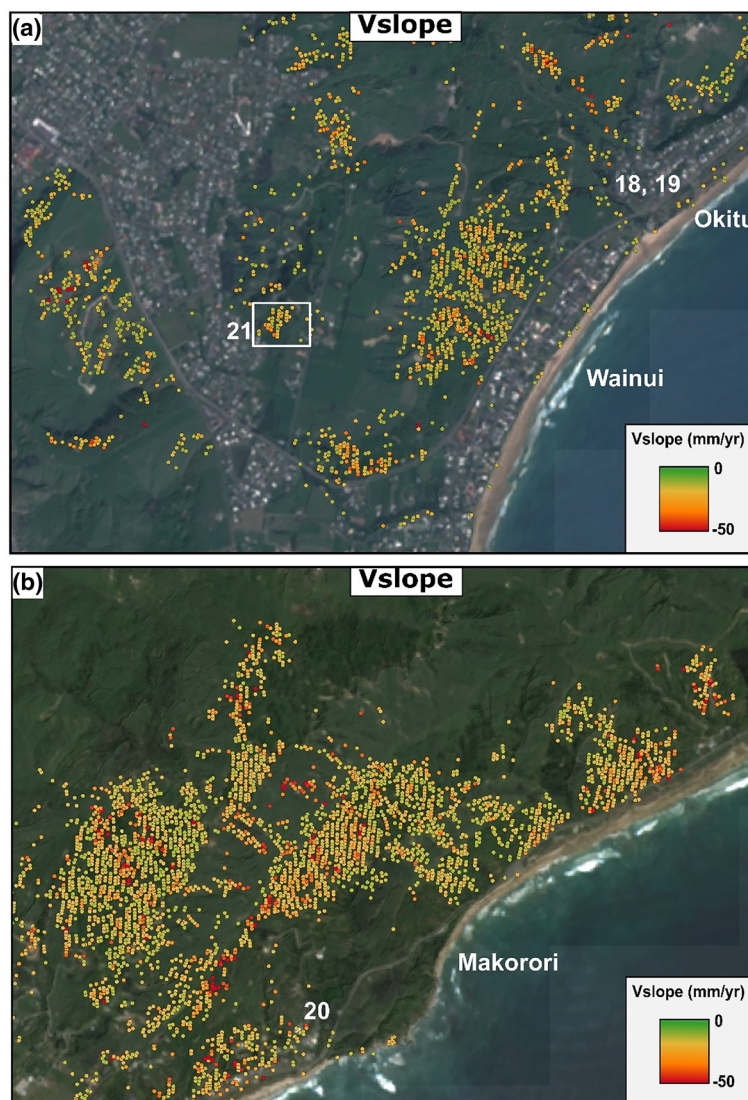
**FIGURE 6** Sentinel-1 InSAR slope velocity ( $V_{\text{slope}}$ ) data for January 2016 to December 2021 for the Wheatstone Road area (a) and Makorori (b). White box in (a) is the extent of the aerial image in Figure 7, including Landslide #21.

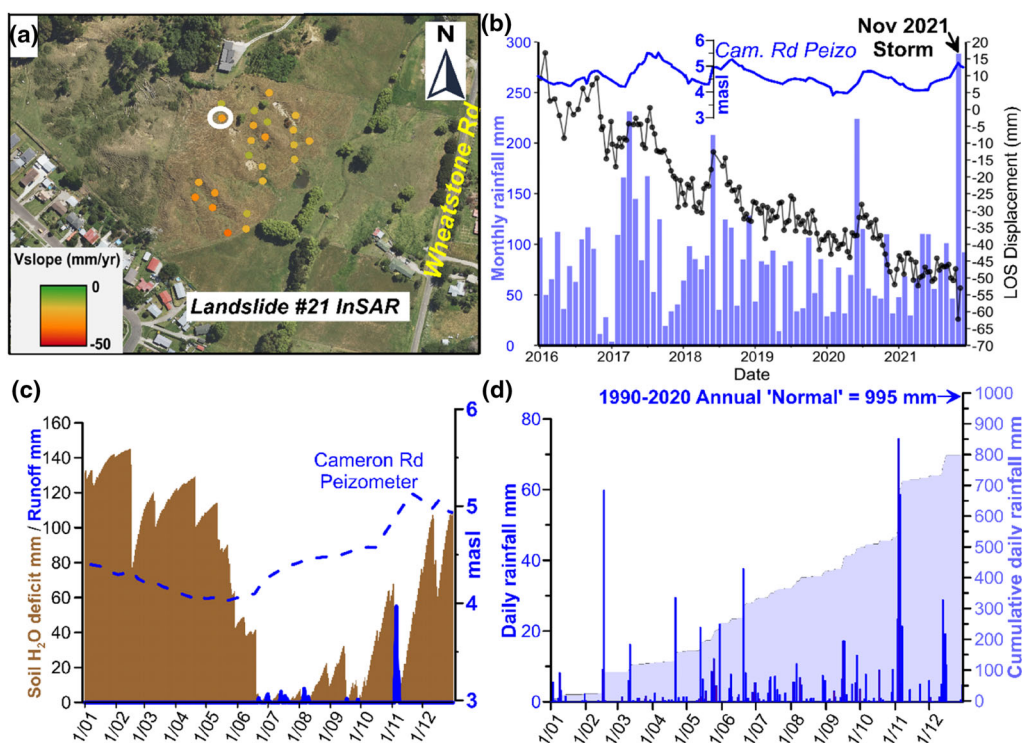
groundwater fluctuations from a piezometer at Cameron Road also shown on the plot (blue line), together with monthly rainfall (blue bars). The velocity pattern (black line) shows that the slope is following a generally consistent annual pattern of movement, with large inflections in the trend due to major rainstorms, causing a pulse of rotational slumping to occur.

A seasonal trend is also present in the InSAR data. This represents annual shrinking (summer drying) and swelling (winter wetting) of the clay-rich soils. The piezometer record also shows that groundwater tracks rainfall input rather closely. Figure 7c shows the 2021 soil moisture deficit and modelled surface runoff from Niwa's Gisborne weather station (Agent 24976), along with the weekly Cameron Road piezometer record. As can be seen from Figure 7c, 2021 was a very dry year, and for the majority of the year until the November 2021 storm, the soils were very much in soil moisture deficit. Figure 7d reports the daily rainfall and cumulative daily rainfall record from the same Niwa station. This again confirms that 2021 was a year of below average rainfall and dry conditions. Until November 2021, Gisborne has only received 55% of its annual average total of 995 mm (based on the 1990–2020 'normal'). Moreover, despite the impact of the November 2021 storm, even by the year end, Gisborne had still only received 80% of its 1990–2020 annual average rainfall total (Figure 7d).

**FIGURE 7** (a) aerial imagery (from 2017) of Wheatstone Road, that reactivated during November 2021 event (see Figure 6a for location); (b) time series of velocity in the LOS acquired from the point highlighted in the white circle in (b), plotted against total monthly rainfall. Cameron Road piezometer (blue line) is superimposed on the plot; (c) soil water deficit (brown bars) and runoff (blue bars) showing dry soil conditions in the months preceding the November 2021 storm, along with Cameron Road weekly piezometer record for 2021; (d) 2021 daily rainfall (blue bars) and cumulative daily rainfall (blue shade), with 1990–2020 mean annual ('normal') total 995 mm. All data from Gisborne Niwa Agent 24976 (<https://cliflo.niwa.co.nz/>).

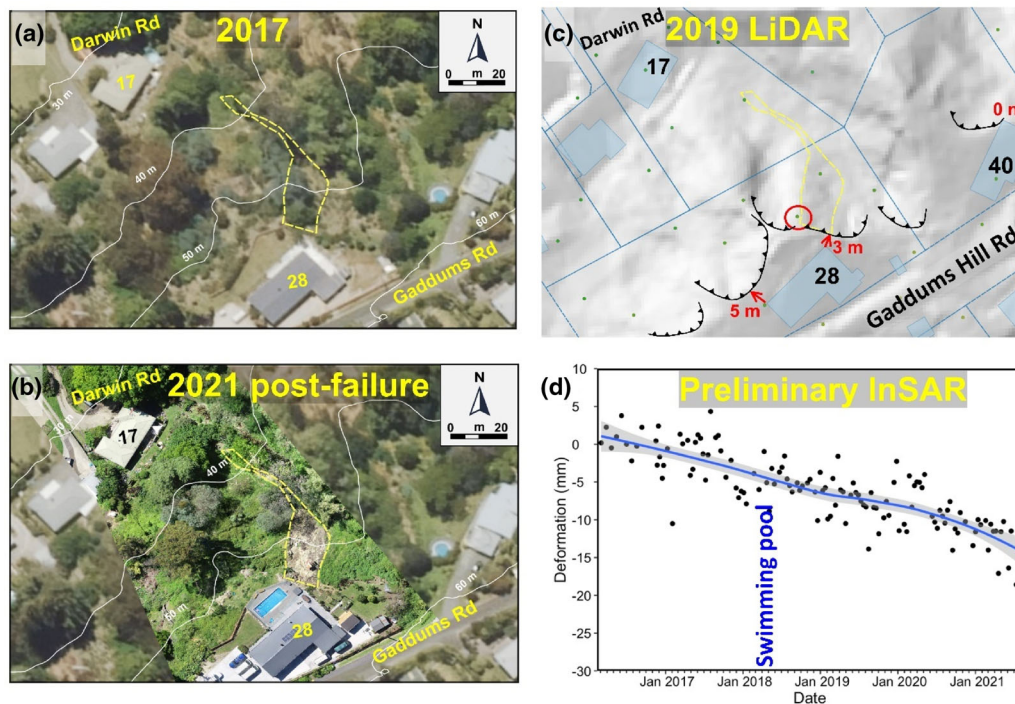
An example is at Gaddums Hill Road (Figure 8). Indeed, the 2019 LiDAR digital elevation model reveals that several landslide headscarps are present along the north-facing ridgeline (Figure 8c). Below these landslide source areas, undulating topography on the slope is indicative of landslide debris. The InSAR data trendline (Figure 8d) shows that the slope velocity prior to swimming pool installation was at a rate of  $\sim 2\text{--}3$  mm/year, and this rate continued until around early 2021. Since then, the slope appeared to show a very slight increase in velocity. In November 2021, the landslide (#16) initiated via rotational slumping adjacent to a swimming pool (installed early 2018), and transitioned in a mobile channelised earthflow, extending downslope onto the 17 Darwin Road property (Figure 8b). So, the November 2021 landslide (yellow hash in Figure 8c) was actually the reactivation of existing landsliding at the site. Thus, the Sentinel-1 InSAR is also useful in monitoring slope velocity in areas of existing landslides within urban Gisborne, that are vulnerable to reactivation.

**FIGURE 8** Slump-earthflow at Gaddums Hill Road, which flowed downslope from north end of swimming pool towards 17 Darwin Road (landslide #16, Table 1): (a) pre-failure imagery from 2017; (b) post-failure imagery from 2021; (c) 2019 pre-failure LiDAR showing existing landslide headscarp areas (black lines) and InSAR target (dot inside red circle); (d) 2016–2021 InSAR LOS displacement showing gradual downslope movement, with slight increase through 2021. Blue line is the 7-day rolling mean and grey shading is the 95% confidence interval.
