# Interferometric Synthetic Aperture Radar (InSAR) and field-based observations of rainfall-triggered landslides from the November 2021 storm, Gisborne/Tairāwhiti, New Zealand

Matt Cook<sup>1</sup> | Martin Brook<sup>1</sup>

<sup>1</sup>School of Environment, University of Auckland, Auckland, New Zealand

<sup>2</sup>Gisborne District Council, Gisborne, New Zealand

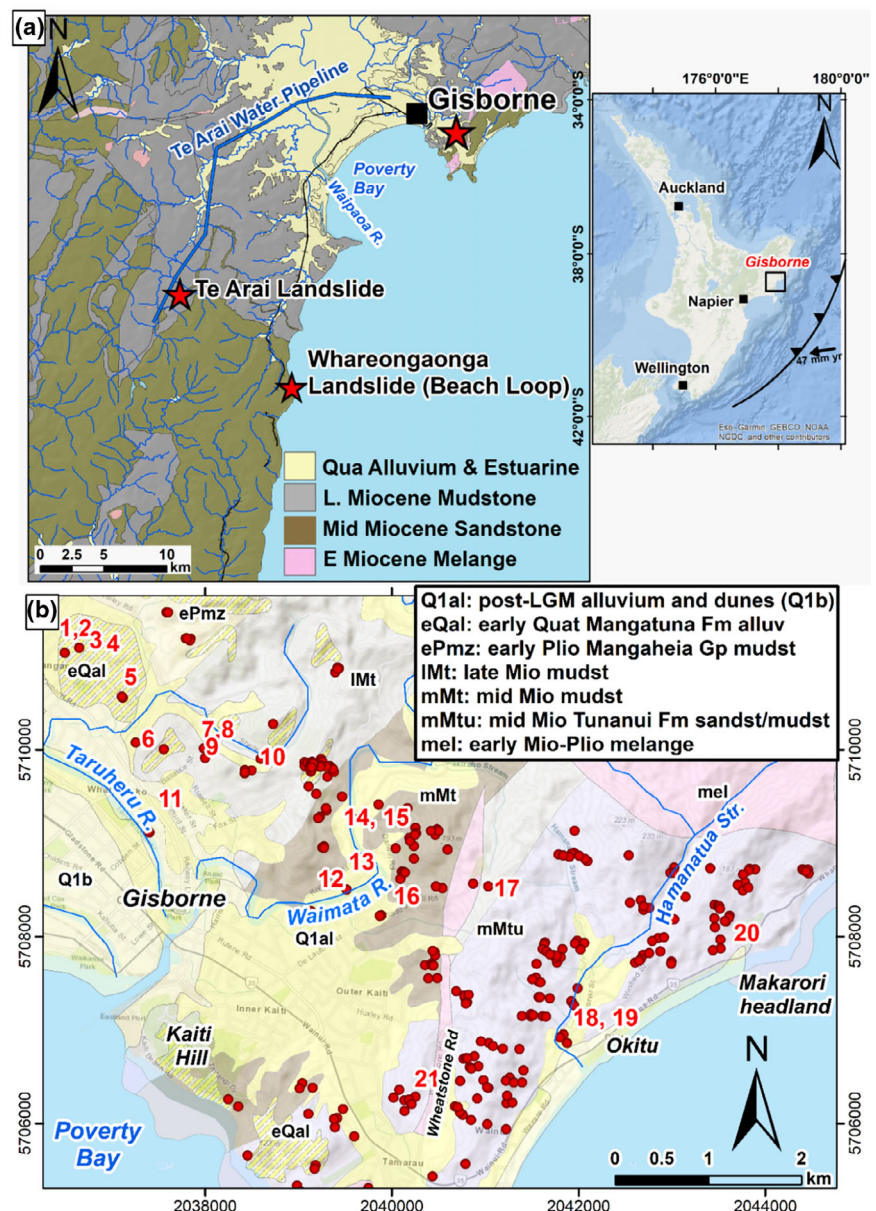
**FIGURE 1** (a) Simplified geology of the Gisborne region with Te Arai and Whareongaonga landslides also shown; (b) landslides (red circles) following the November 2021 storm in and around Gisborne city and suburbs (numbers are landslides visited and reported in Table 1), and geological abbreviations are from Mazengarb and Speden (2000).

L#	Location	Landslide characteristics	$A_s^\circ$	$L$ m
L1	Winter St	Not reported until months later by neighbours reporting sediment discharge. Downhill of Argyll St, movement of unstable low angle failure; complete failure in March 2022 storm	15	38
L2	Argyll St	Large tension crack forming headscarp of shallow slump extending from 24 to 28 Argyll; worst affected 26 Argyll; major reactivation following March 2022 storm; runout/toe removal at 35 Winter St exacerbating factor	8	35
L3	Diana Drive	Slumping on boundary resulting from neighbour landscaping close to foot of retaining wall; exacerbated by weight of water in swimming pool close to edge	33	20
L4	Belgium Tce	Moderate-sized slip on boundary between #4 and adjacent property, no obvious contributing factors	38	40
L5	Massey Rd	Landslide on steep slope adjacent to garage; tree removal on slope a factor; debris impacting property on Oswald St below	28	30

L6	Clifford St	Significant landslide undermined deck at 371; stormwater discharge onto unstable slope & weight of swimming pool on edge of steep face contributed; s124 notice; debris & threat to 395 Clifford	36	70
L7	Hill Rd	Major landslide; large unconsented retaining wall and fill with poor drainage controls failed; blocked Hill Rd isolating occupant requiring urgent medical treatment; runout onto Ballance St	40	70
L8	Hill Rd	Significant tension crack with some slumping at edge of face at 194; risk to 194a&b; s124 notices issued	31	12
L9	Stanford Cres	Slumping of slope above house exacerbated by vibrations from truck unloading large digger on road reserve above slope.	27	13
L10	Richardson Ave	Reactivation of 2019 landslide; new cracking & slumping below ridgeline near house; swimming pool tilted; runout of earthflow constrained within gully	40	90
L11	Stout St	Slumping on land on riverbank caused by failure of stormwater system	42	15

L#	Location	Landslide characteristics	$A_s^\circ$	L m
L17	Gaddums Hill Rd	Collapse of slope on road edge undermined power transformer; debris flow downslope with damaged fences on adjacent blocks; stormwater from adjacent houses a factor	33	40
L18	Williamson Stre	Failure on stream bank driven by flood height affecting toe	28	15
L19	Moana Rd	Failure on stream bank driven by flood height affecting toe; exacerbated by high levels of water flow from road culvert on headscarp	28	10
L20	Sirrah St	Collapse on bank close to house; blocked road isolating ill person	38	25
L21	Wheatstone Rd	Shallow slumping on southeast-facing slope; actively deforming for several years	45	82
